Port Sanilac Harbor BreakwatersPort Sanilac, Michigan

Table 74  
Lexington Harbor Breakwaters  
Lexington, Michigan

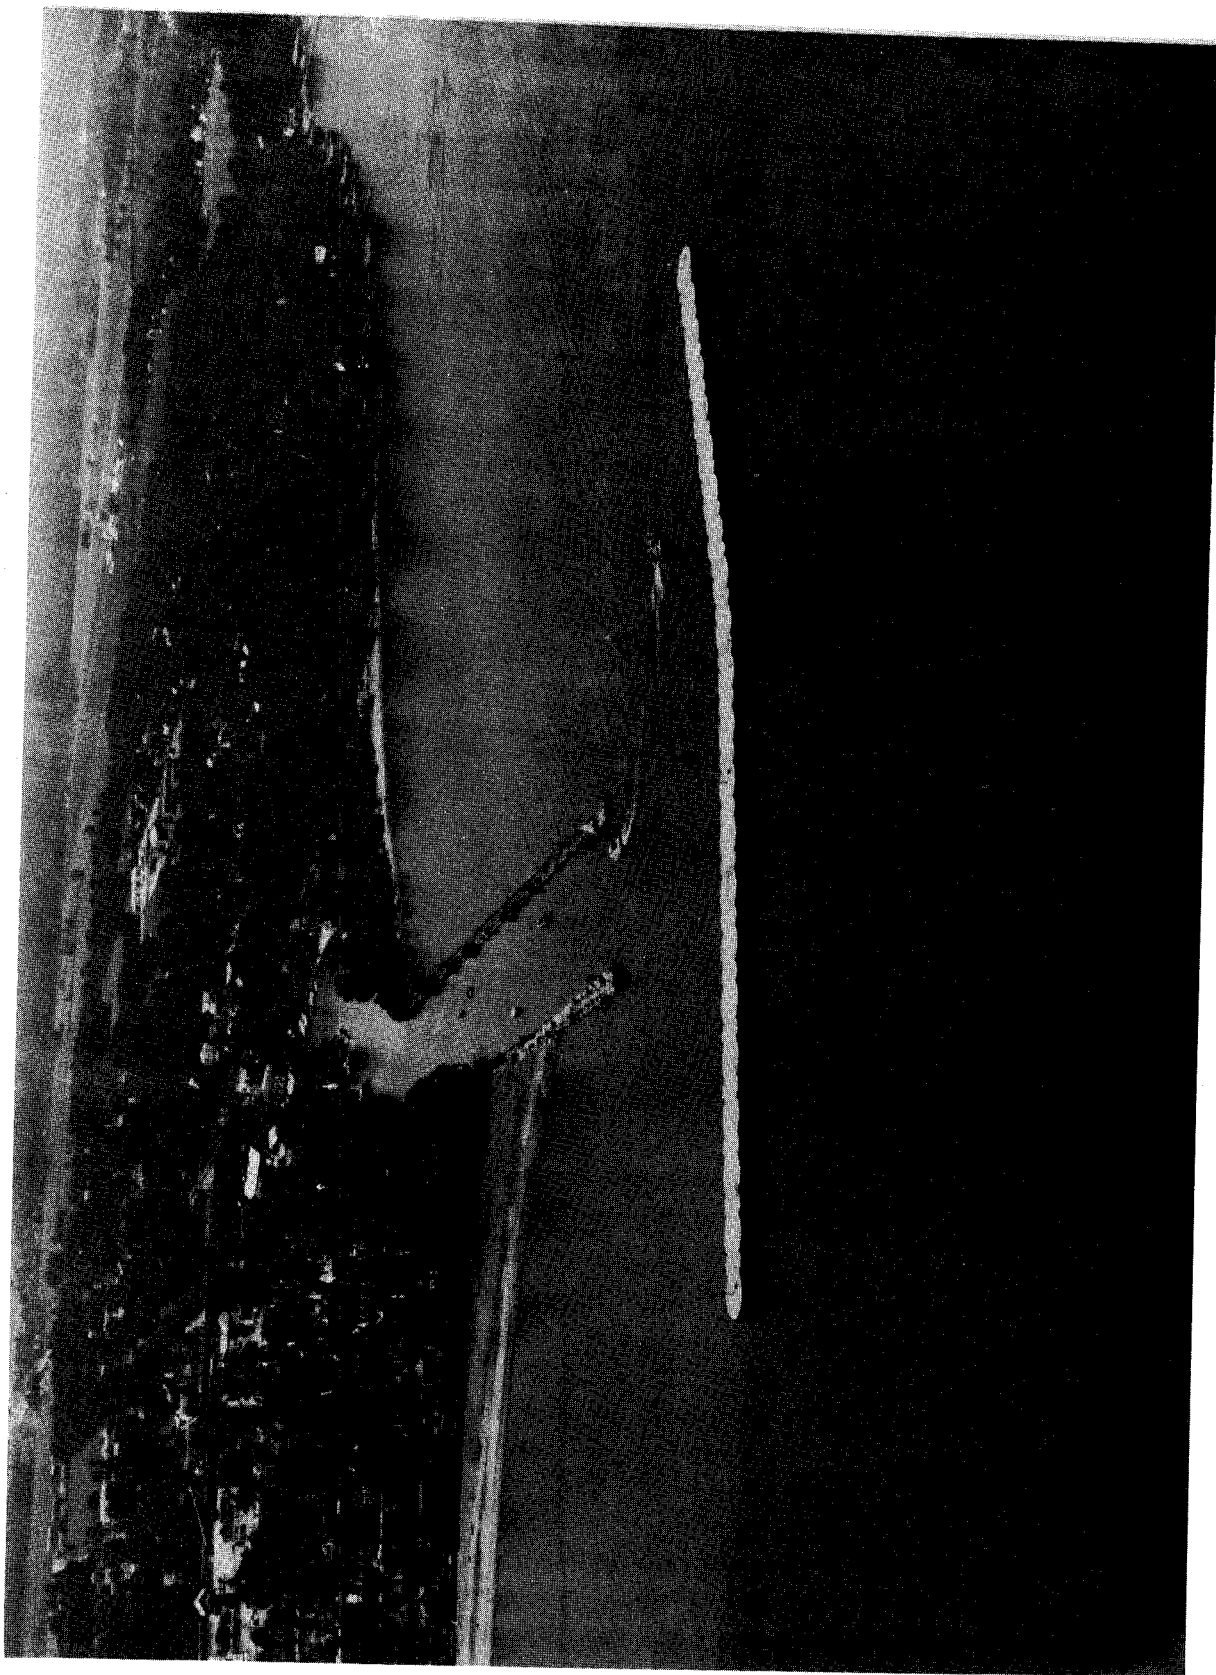
Figure 216. Aerial view of Vermilion Harbor, Ohio

1986	The structures presently are considered in good condition. An aerial view of the Vermilion Harbor structures is shown in Figure 216.
